archi|DOCT

Design of a prototype for the doors of the organ of the Cathedral of Tarragona

Jordi Payola Lahoz // Universitat Politècnica de Catalunya

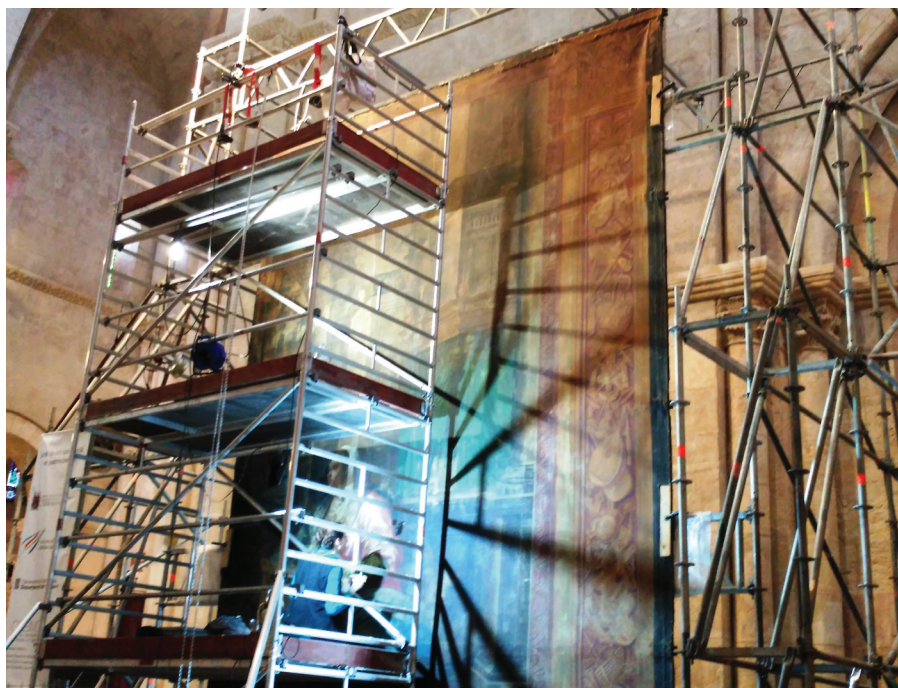
Figure 5.

The supporting scaffolding of one of the frames.

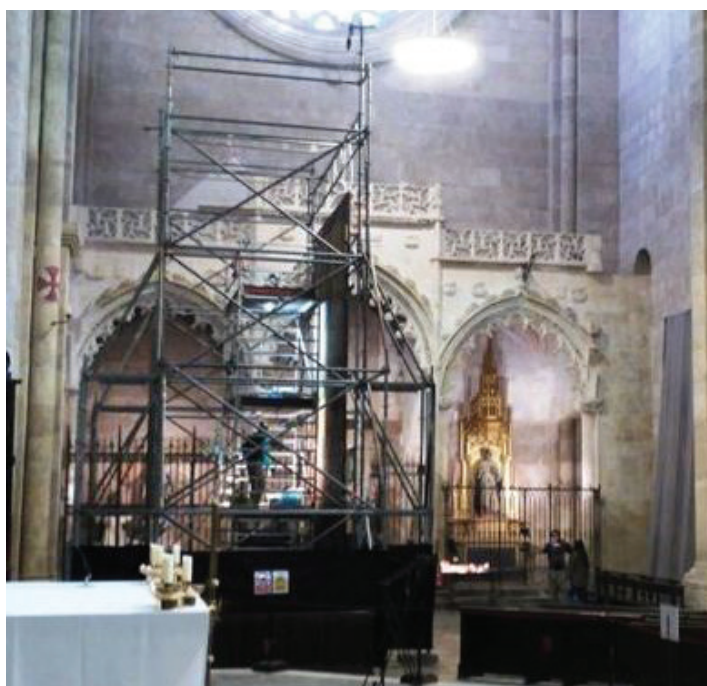
Figure 6.

The supporting scaffolding of one of the frames.

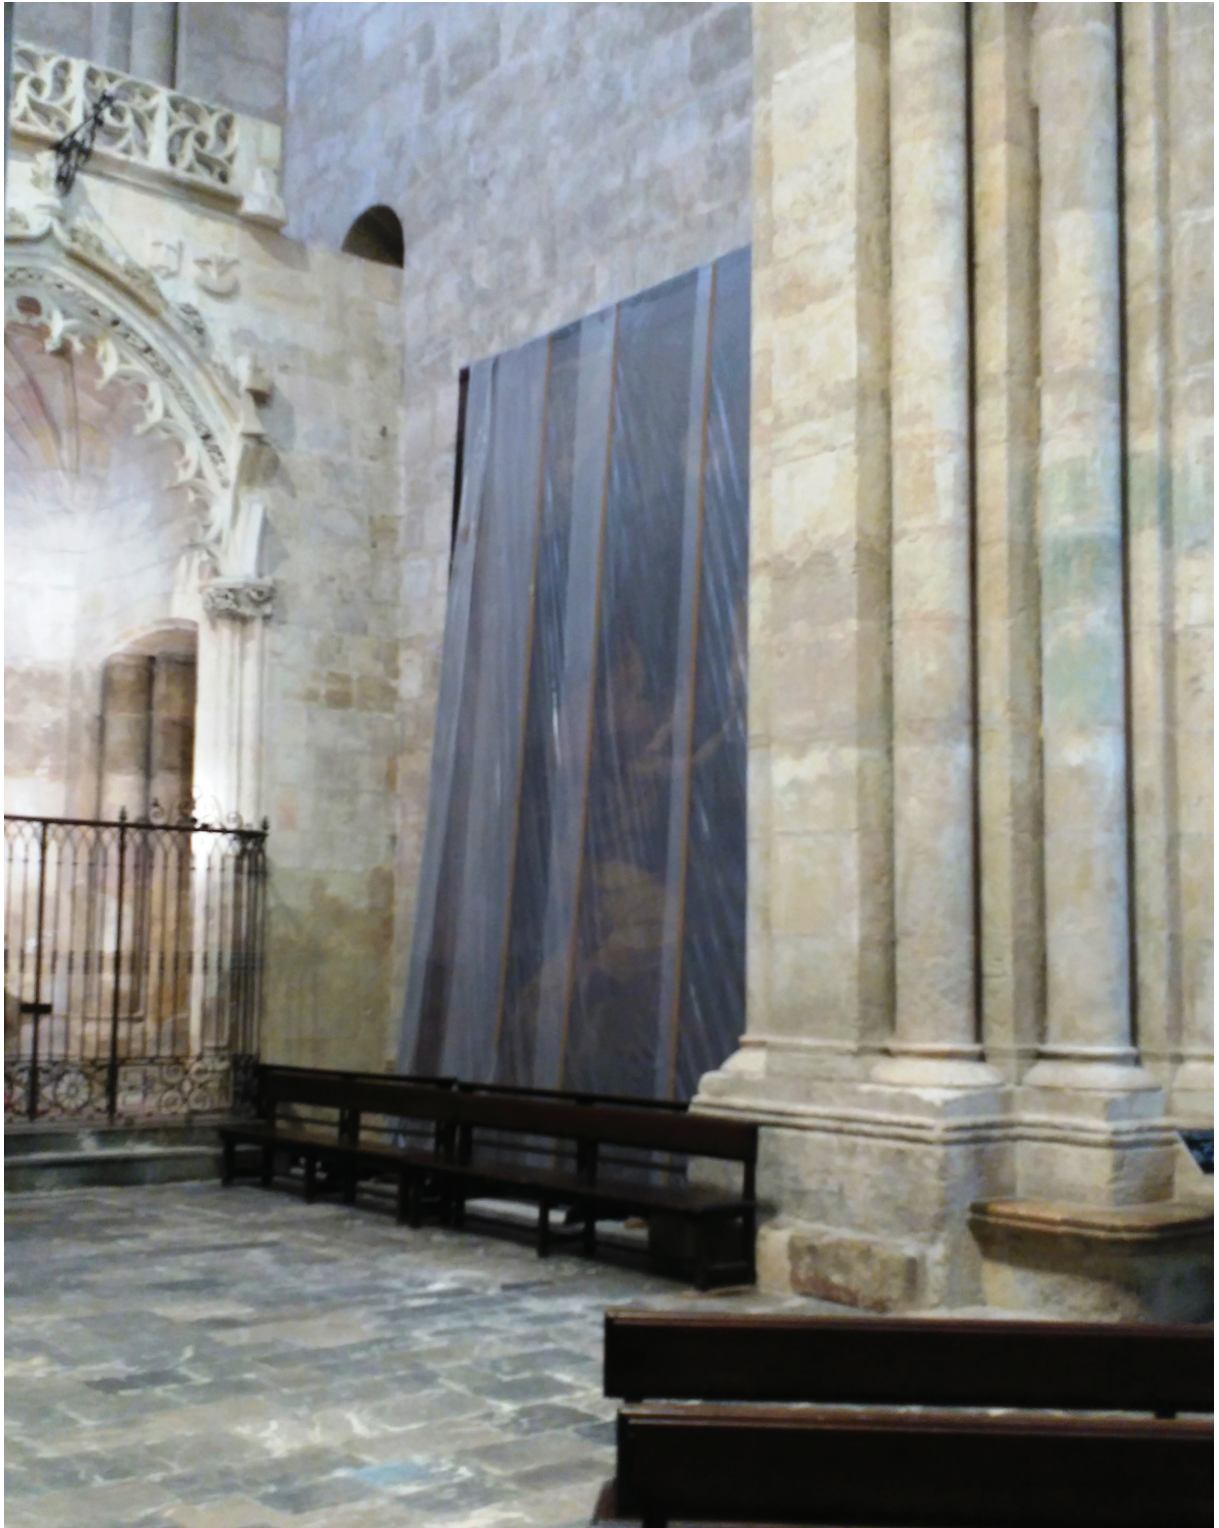
Figure 7.

The state in which the doors were found.

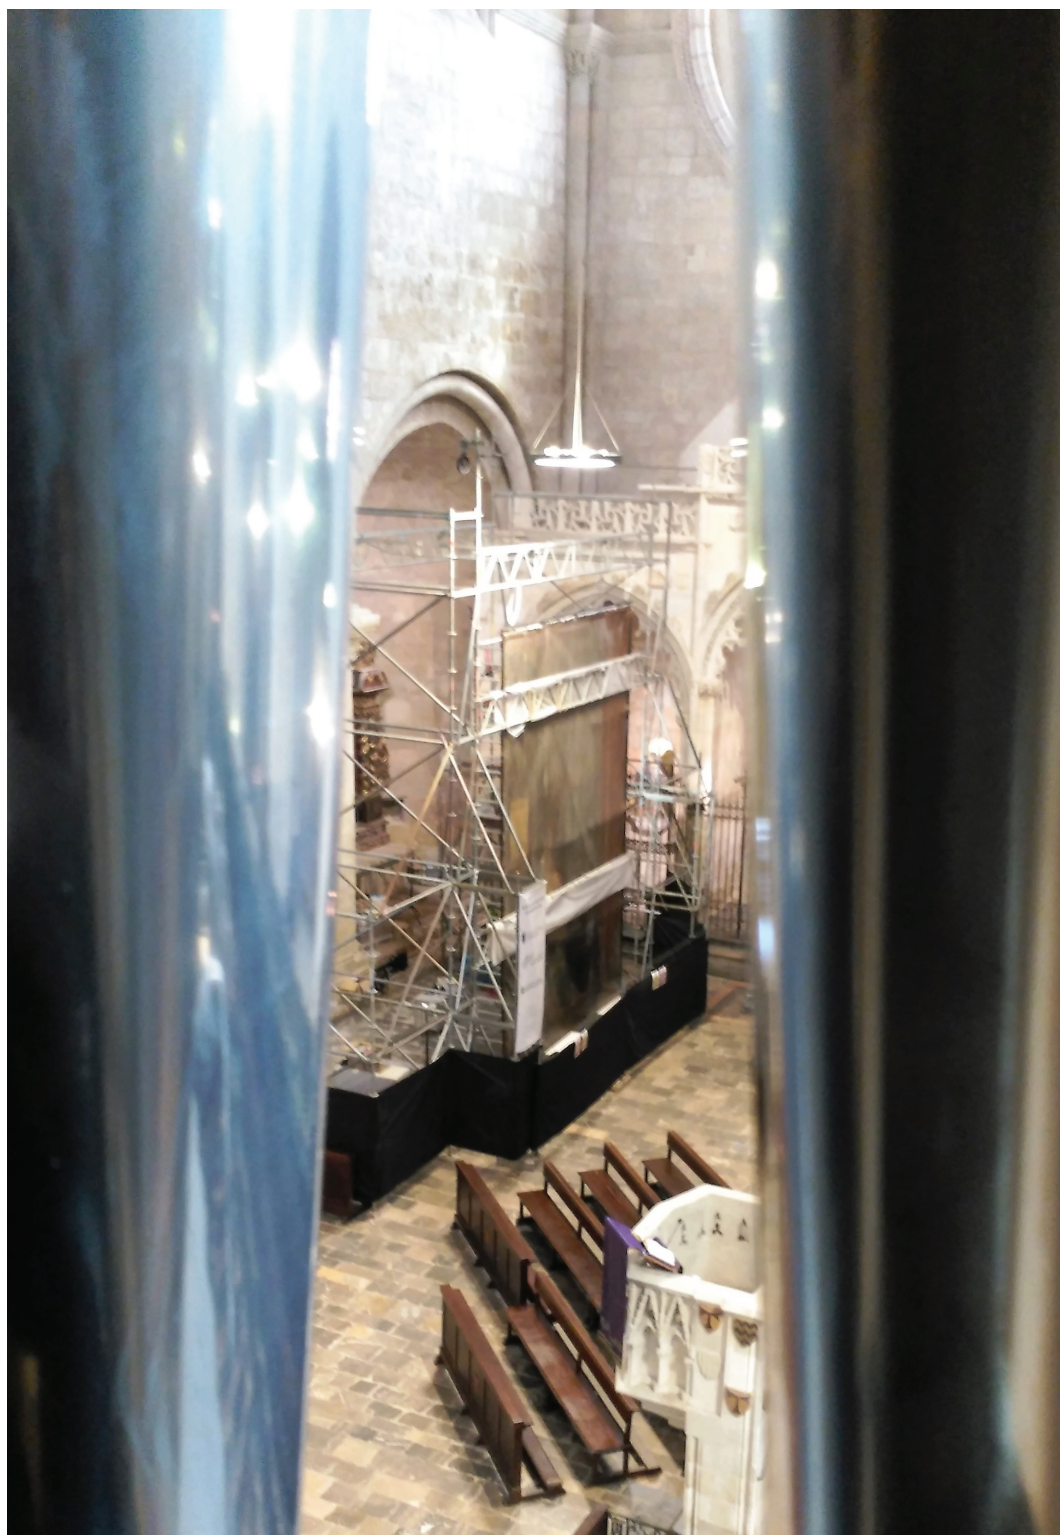
Figure 8.
The scaffolds as a door support.

One of the facts we gathered in the displacement of the first door to the provisional scaffolds was the weight of each element. Its weight, 2.16 kN, included the linden wood structure, the fittings and joints of the 5 hinges, the two canvases (interior and exterior) and thousands of nails with wide heads by which are fastened to the frame. This information is very important since, first of all, it enables us to know the maximum forces on supports of the anchors of the hinges (vertically as much horizontally) and in second place it gives us an approximation of the weight of two canvases, about 70 m² each frame. The first exercise consists of subtracting from the total weight of 2.16 kN, the weight of the wooden structure and the fitting of wrought iron. The resulting value would be the weight, more or less precise, of the canvases and the fastening nails. This weight will be practically the same one that the new frames should support.

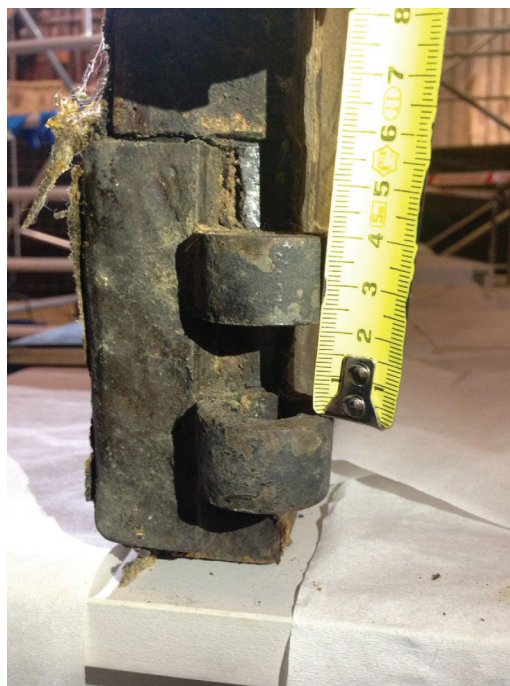
Figure 9.
Inferior hinge of the frame.

Other important elements to consider and to have in mind are the five hinges which fix the frames to the organ. They are made of wrought iron, are 150 cm long and weight 1.2 kN each (6.0 kN in total, by no means negligible).

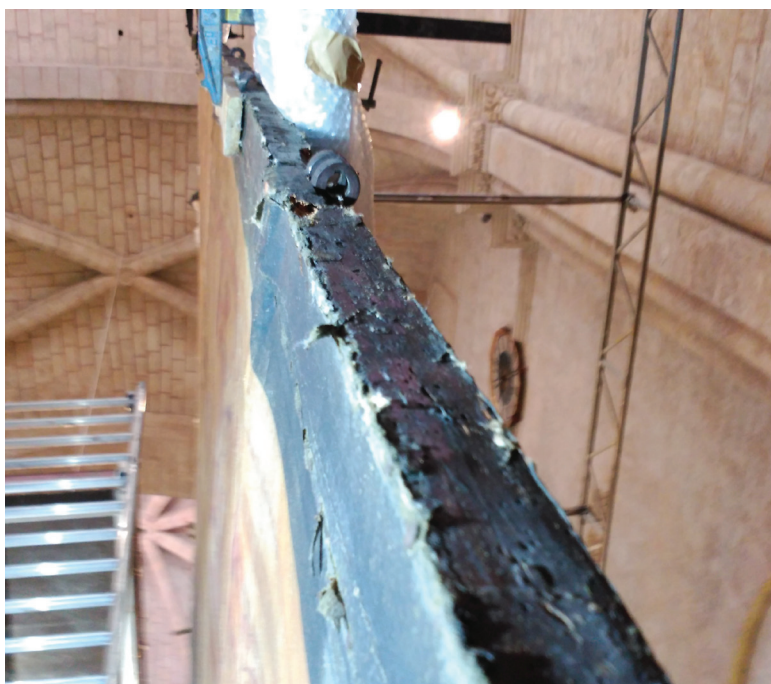
Figure 10.
Image of the bad condition of the frame.

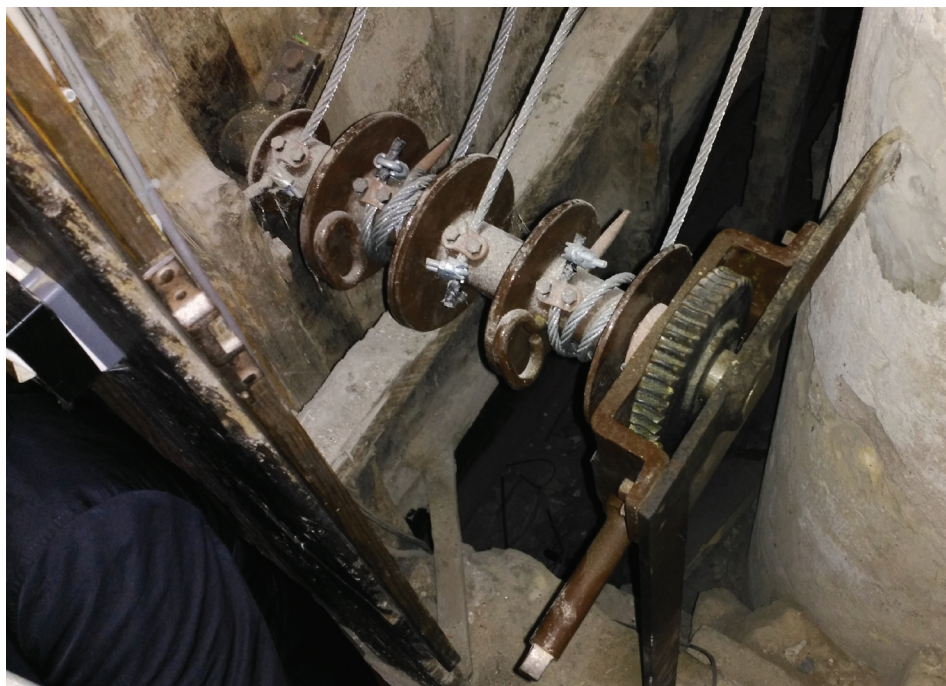
Figure 11.

Inferior roller of manual operation for opening and closing.

One of the wonders of the doors is its system of opening and closure. It is a manual mechanism operated by a handle - situated on the inferior bench of the organ - which rotates a roller (image 11) joined by the two heads of a continuous cable which, according to the direction of rotation, opens or closes the frames. An ingenious system of pulleys and bearings (image 12) which has been repaired and enhanced in diverse recent proceedings, with some changes in the materials but maintaining the same initial essence, and which use is now intended to be recovered. This is a good new, but an additional constraint added to the assembly which has to be taken into account since it has not been used in many years.

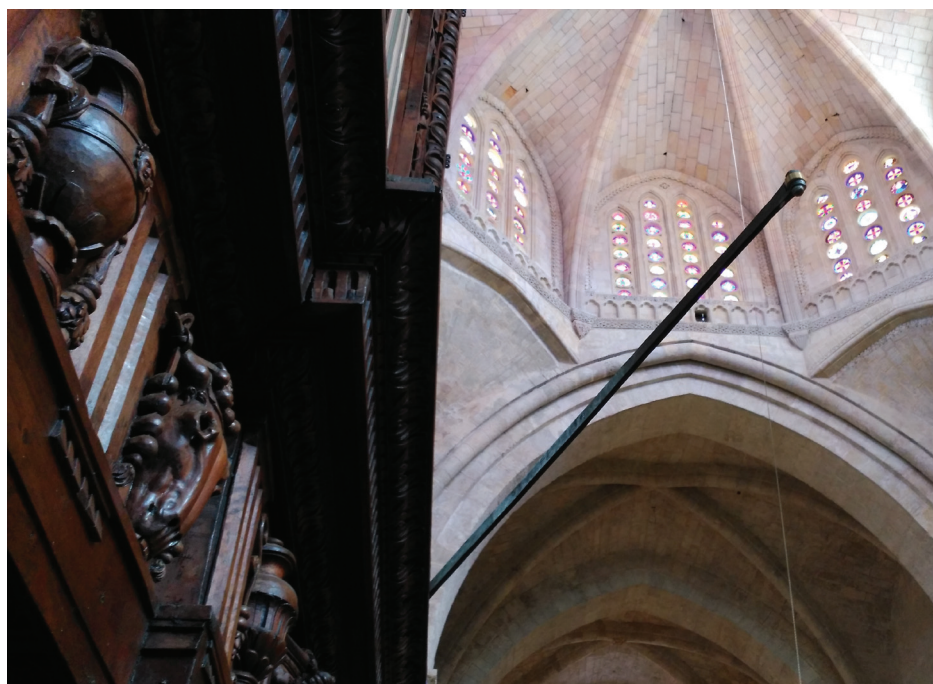
Figure 12.

Arm with bearings which pushes or pulls the doors.

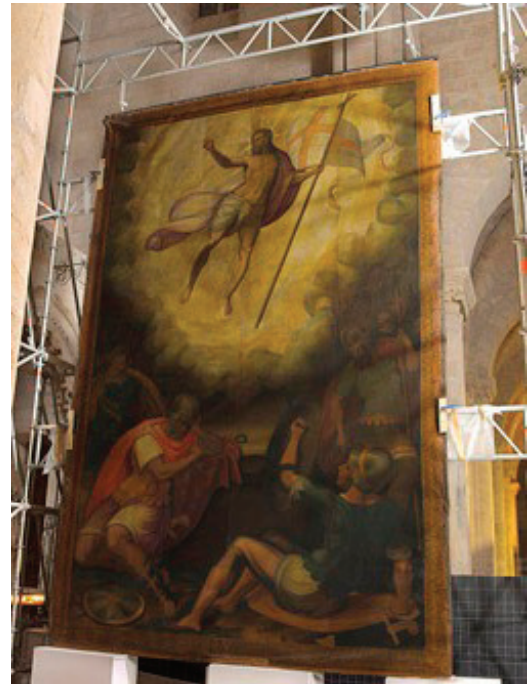
Figure 13.
Image of initial state of the first frame.

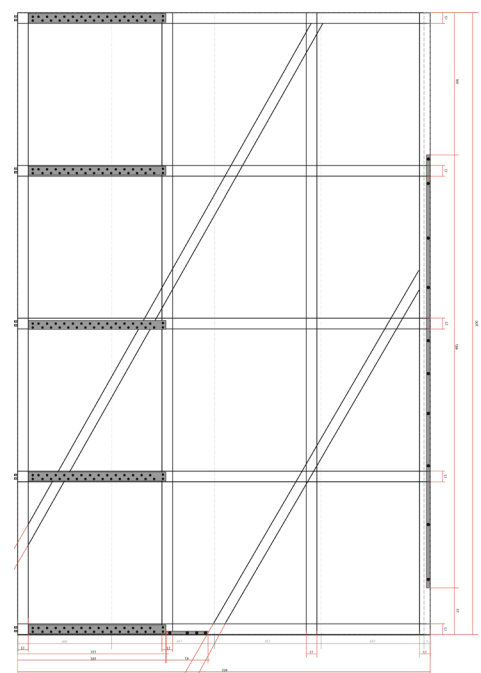
Figure 14.
Initial sketch done by the restorers.

By palpating and in backlighting the geometries and the dimensions has been extracted to elaborate a sketch of the image (fig. 14) which has been the base of its analysis, and which we will consider an approximation from which we can start the analysis. In despite of its geometrical proximity, it will never be enough similar to the real behaviour of the system, because we don't know the typology of the joints, its rigidity and the participation of the canvases and the hinges among other things.

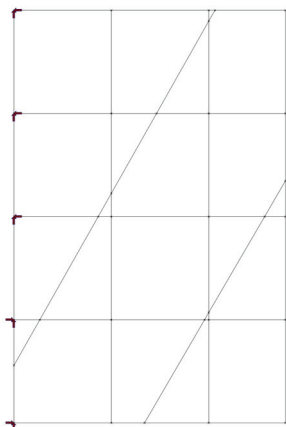
Figure 15.
Reactions of the frame.

Technically the values which has been chosen as notable, starting with the distribution and the direction of the reaction on the furniture of the organ (fig. 15) or the instantaneous maximum deformation of (0.8 mm – fig. 17) are the maximum compression in absolute value (2.35 kN – fig. 16), the maximum stress under compression (0.49 N/mm²) and the maximum value of horizontal reaction. Furthermore, these are the moments and maximum shear forces (which help to know if there is an over-solicited element) although a priori they don't affect the global behaviour of the frames in a notable way (fig. 18 and fig. 19).

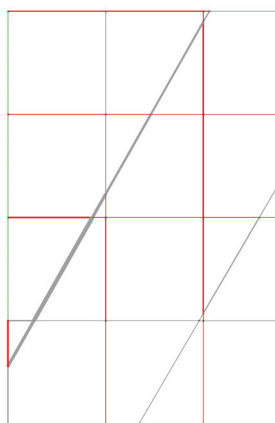
Figure 16.
Diagrams of the frame.

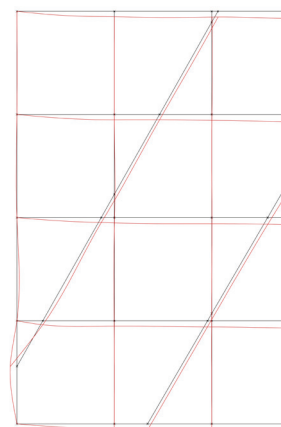
Figure 17.
Deformation of the frame.

Analyzing more particularly the previous images, it can be seen that the point of rotation of the frames is situated between the third and fourth hinge, encountering the maximum reaction in the fourth hinge, a position near the diagonal with the maximum of compression. The disposition of these encounters between the bars seems little accurate, since it ends up causing the maximum of shear forces and bending moments, which accumulate the maximum stresses (fig. 20) in the bars not considered as principals.

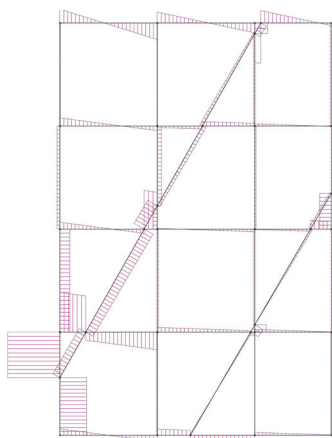
Figure 18.
Diagram of shear forces of the frame.

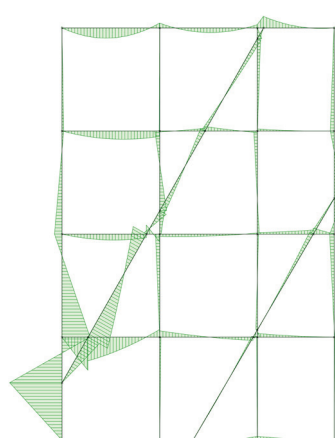
Figure 19.
Diagram of bending moments of
the frame.

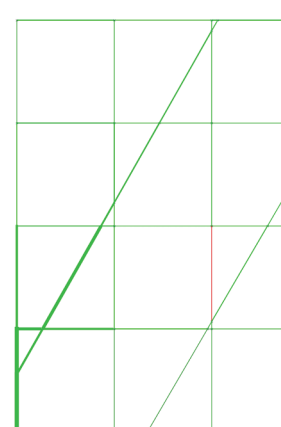
Figure 20.
Diagram of maximum global
stresses of the frame.

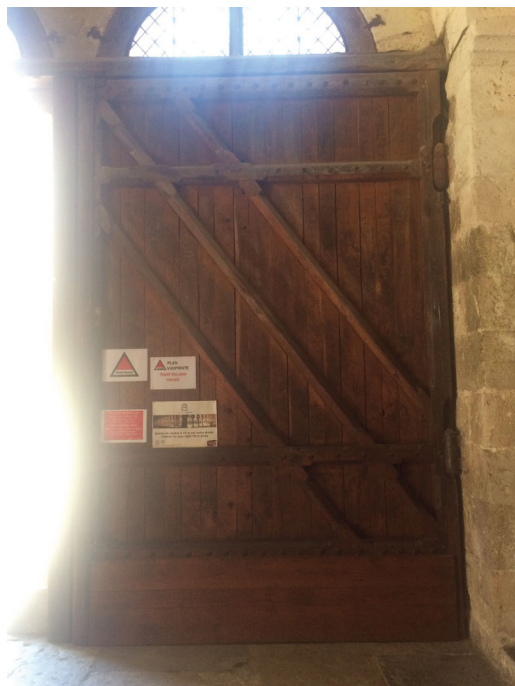
Figure 21.
The door of Moissac.

1. A solid wooden door located in the abbey of Saint Pierre de Moissac (Occitanie, France). This is a secondary door of the premises, solid, wooden with a very clear disposition of posts and diagonals, and the inferior part has a double thickness (fig. 21). It has been considered for trebling the compressed diagonal, and duplicating the superior horizontal tensed element, with the idea of distributing the stresses in different parallel bars. It disposes of two hinges.

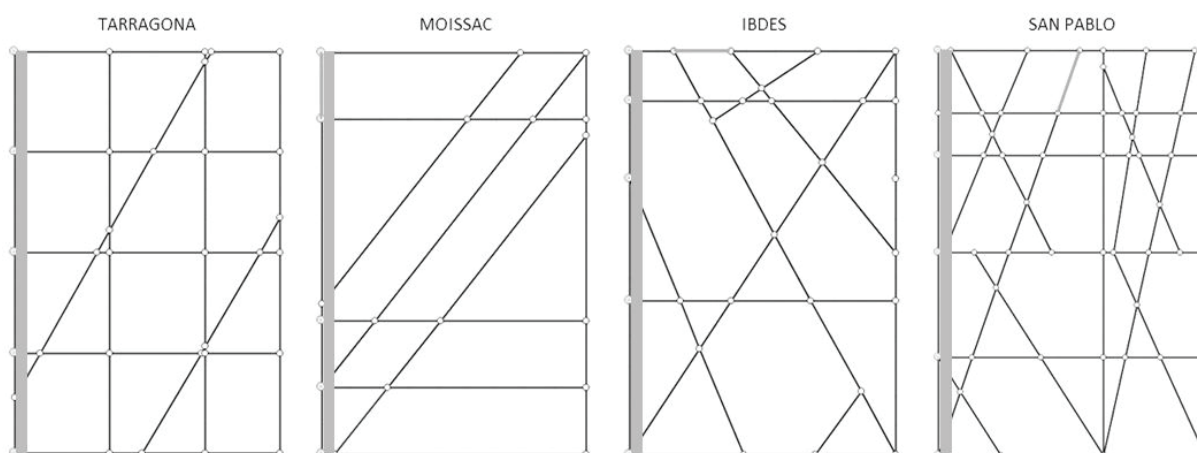
Figure 24.

Initial models (with real adapted geometry) which has been compared in the first phase.

Once the cases for comparison are chosen, it is needed to homogenize some of the particular properties, like the dimensions, the applied loads or the number of the supporting hinges, among other things. This is a first phase of adjustment in which specific data of original case is lost for approximating toward the case study, to be able to compare some parameters and results from a more objective point (fig. 24).

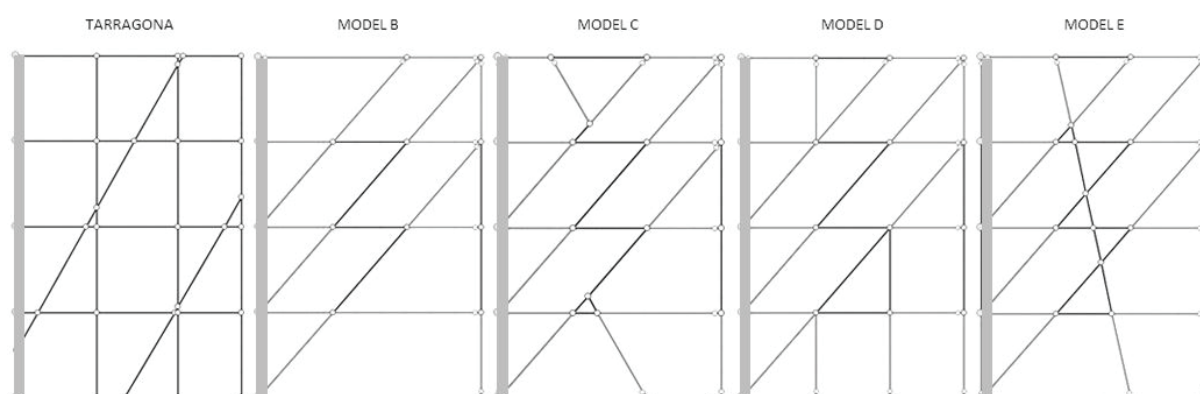
Figure 26.
Comparing geometries of the analyzed models.

According to these commentaries, some first models are proposed (fig. 26), adapting the geometry to the position of the five hinges that require to keep the 5 horizontal bars of the Tarragon model, but some diagonals are introduced like the style of the 'Moissac' Model.

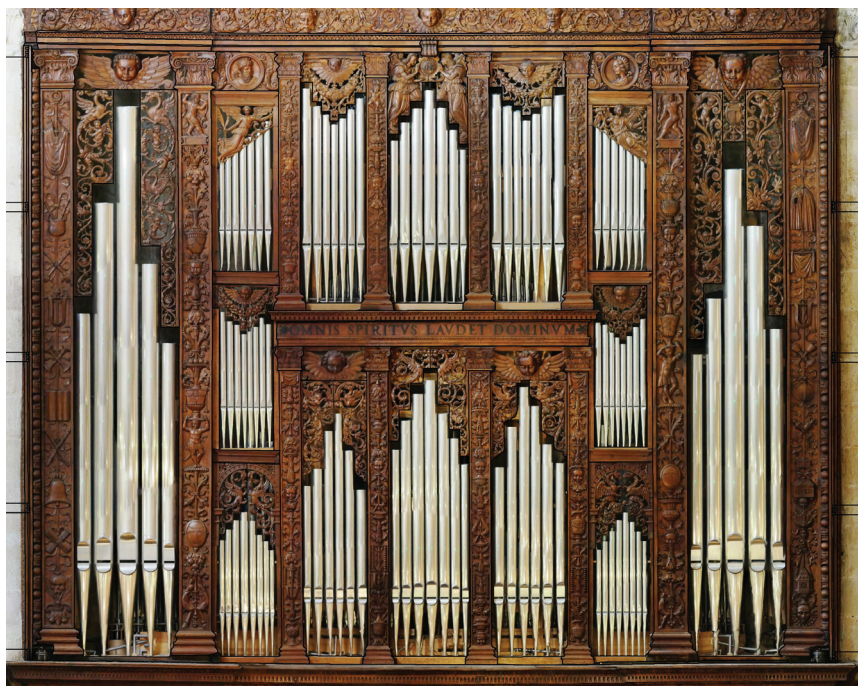
Figure 28.

Image in real magnitude of the furniture of the organ captured by drone (Octocam-maps).

The doors were removed some years ago, in order to renovate the interior of the cathedral and the pipe organ, and no documentation was kept. Until the beginning of the intervention they were left lent over a wall until the moment that it was decided to restore and place them in their original position. The state of the wood is very poor, regardless no decision would be made about the intervention until it is possible a deeply analysis. But this fact has motivated this study, based on a real case and situation, even if the conclusions may not be used at the real project and intervention (fig. 28).
